Case Study: Measuring Supplier KPIs

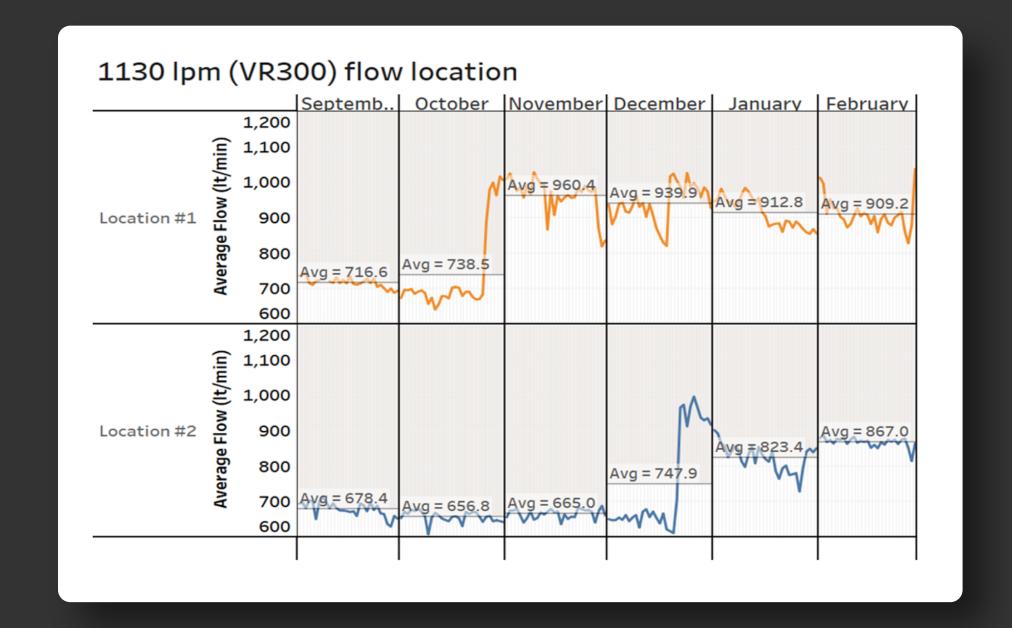
Data revealed that locations #1 and #2 (refer to graph) were performing at approximately 700L/m, which was significantly below the required nominal rate of 1000L/min. The low flow rate indicated pumps in these locations were causing extra non-productive, off-circuit time for the haul truck fleet.

Consistent reporting from Adapt **O** and customer service team led to the necessary repairs to the pumping systems by the operator. One pump was replaced and the remaining were completely rebuilt in-situ. Repairs were completed within a few months.

Both dispensing locations improved their flow rate by reducing refuelling time by 1.6 minutes per truck-equivalent to adding 31.2 hours of truck production per month.
